Manhole Inspection Summary

Manhole # S35WW1004MH

Insp Date: **1/30/07 10:04 AM**

Location Address: **348 BROADMORE RD**

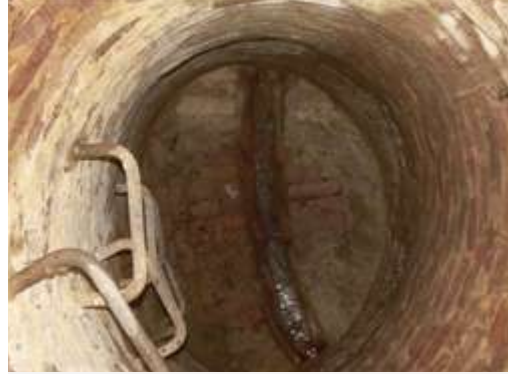
Top View

Bench debris.

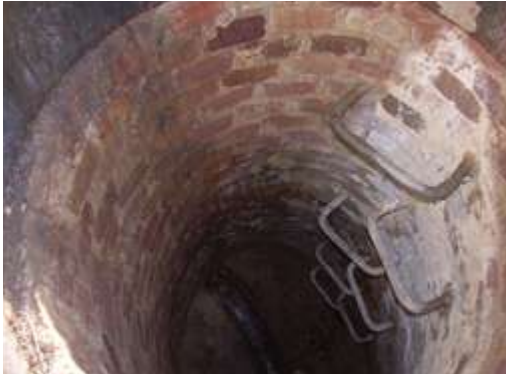
Defect

Frame leaks. Frame offset. Adjustment deterioration and infiltration. Corbel and Barrel infiltration - other side.

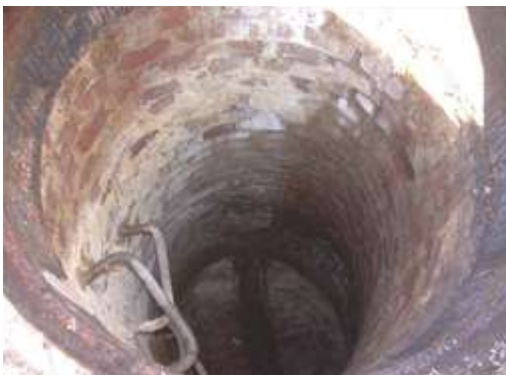
Defect

Adjustment, Corbel and Barrel infiltration.

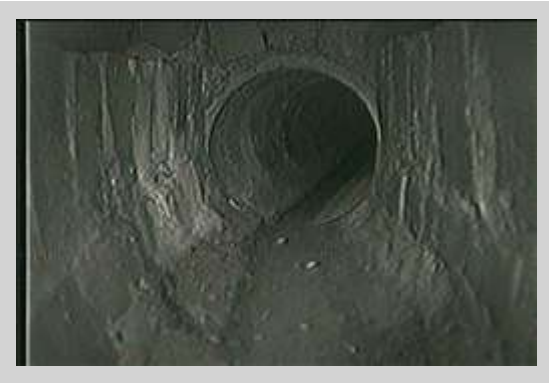
8 in. Circular Gravity Sewer Pipe Out @ 12 O'Clock

Infiltration: **Evidence** Pipe Seal Cond: **Unknown**

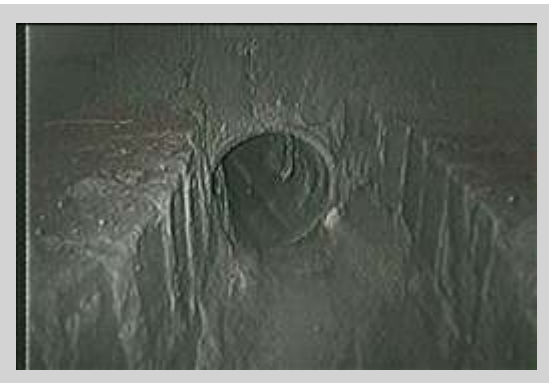
6 in. Circular Gravity Sewer Pipe In @ 5 O'Clock

Infiltration: **Evidence** Pipe Seal Cond: **Unknown**
